ROV Maintenance LOG

Topic: CCU 主機更新後 ROV 無法連線問題修正

Date: 2024.06.03

ROV: ECA H800

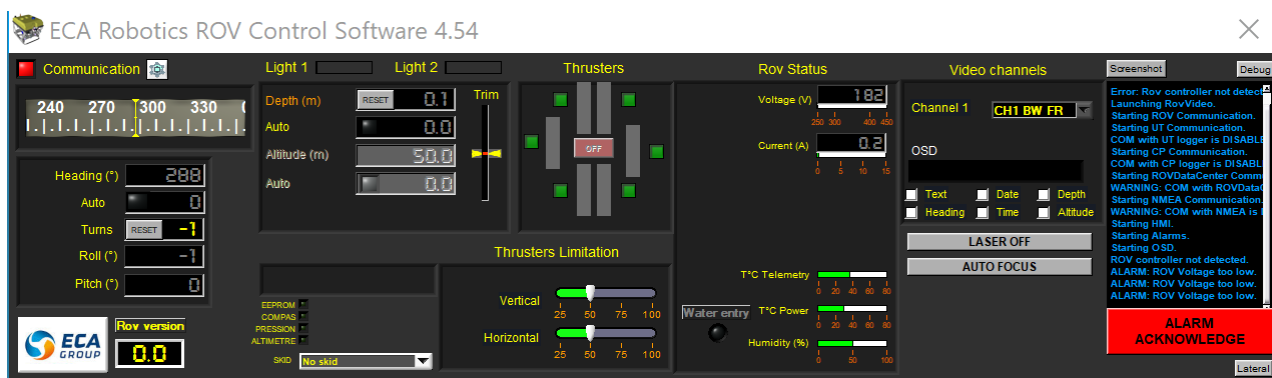
CCU 的電腦主機在更新後因為 Moxa interface board 的設定被還原導致 ROV 無法和 CCU 電腦連線 (圖一)，需要重新進入 Device Manager 設定解決連線問題。

圖一、ROV 的 Human Machine Interface (HMI)連線狀態一直顯示紅燈。

1. 搜尋並進入 Device Manager
2. 點選 Multi-port serial adapters > MOXA CP-114EL Series (PCI Express Bus)
3. 檢查四個 COM 的設定是否與圖二相同，Port 1 的設定為 COM2，而 COM2 與 COM5 的 Interface 為 RS-485 2W，COM3 及 COM4 則是 RS-232

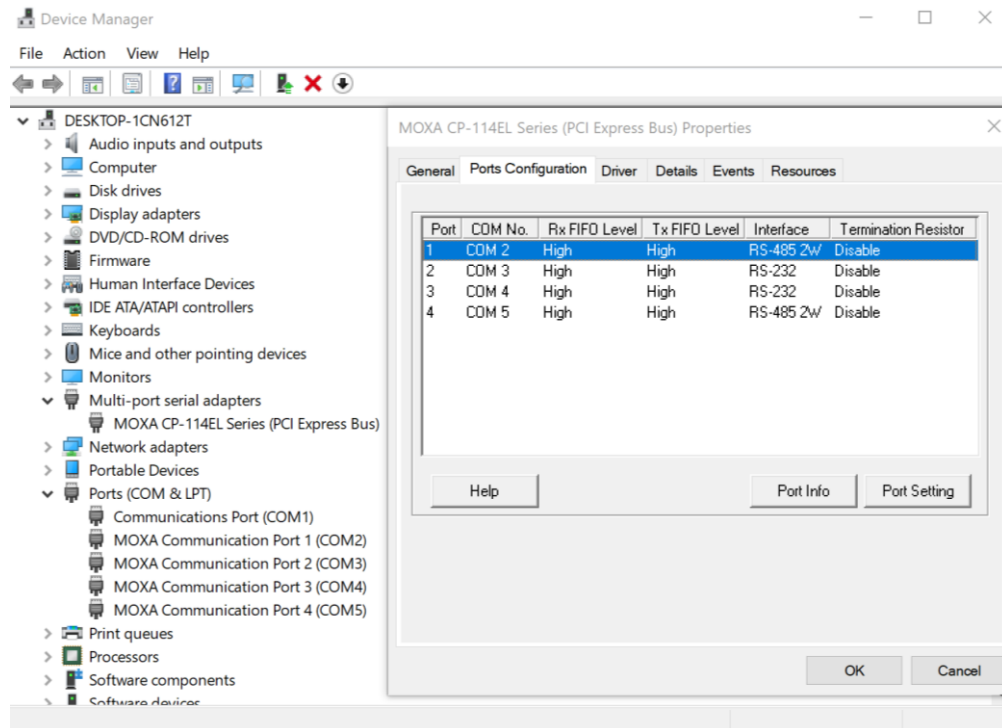
圖二、四個 COM 的設定畫面。

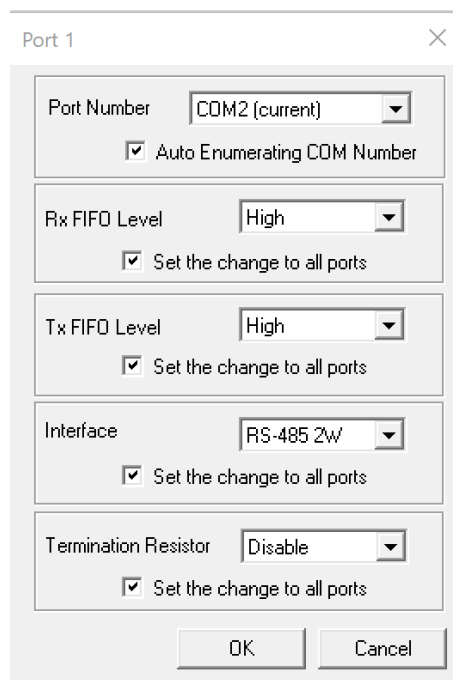
圖三、Port 的設定畫面。

4. 如果有出入，點兩下滑鼠以設定 Port 的參數(圖三)，設定單一 Port 時記得取消 Set the change to all Ports 的選項。
